**Flood Control Project Maintenance
Levee Inspections**

Fall 2011 Levee Maintenance Deficiency Summary Report

Reclamation District No. 0070 Meridian

Levee Inspection Report By Mile - Fall 2011

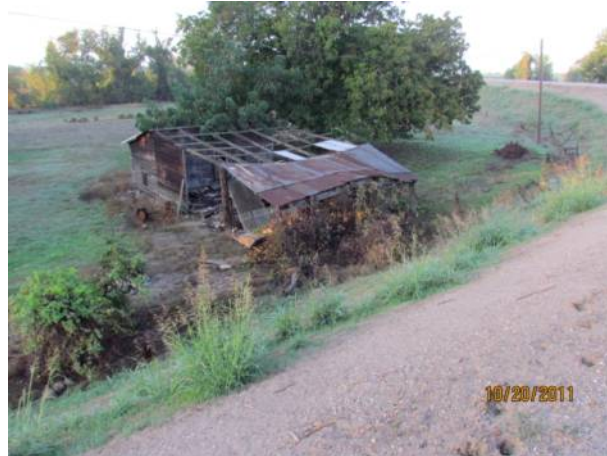
Levee Mile Report Line	1
Start Levee Mile	0.95
End Levee Mile	0.95
Location	Land Side
Category	Earthen Levee
Item	Encroachments

LMR No.	Levee Mile		Category	Item	Location *	Rating **	Action/Comment	GPS Latitude/Longitude		Issue No.
	Start	End						Start	End	Photo
1	0.95	0.95	Earthen Levee	Encroachments	LS	PO	Buildings	39.146211 ° -121.844551 °	39.146211 ° -121.844551 °	1 Y
2	3.14	3.26	Earthen Levee	Animal Control	LS	M	No rodents visible, but rodent burrows visible; need to backfill and compact or grout burrows.	39.158098 ° -121.877850 °	39.157502 ° -121.879772 °	3 Y
3	3.27	3.27	Earthen Levee	Seepage / Sandboils	LS	C		39.157500 ° -121.879908 °	39.157500 ° -121.879908 °	2
4	6.82	6.82	Earthen Levee	Animal Control	LS	M	No rodents visible, but rodent burrows visible; need to backfill and compact or grout burrows.	39.194063 ° -121.916663 °	39.194063 ° -121.916663 °	4 Y

View of the building along the L/S toe.

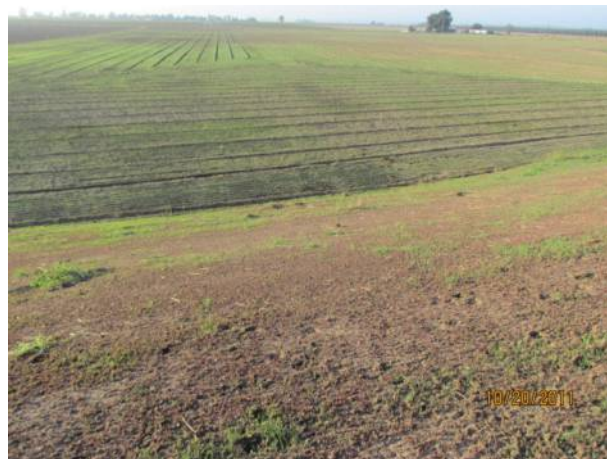
Levee Mile Report Line	2
Start Levee Mile	3.14
End Levee Mile	3.26
Location	Land Side
Category	Earthen Levee
Item	Animal Control

View of the rodent holes along the L/S slope.

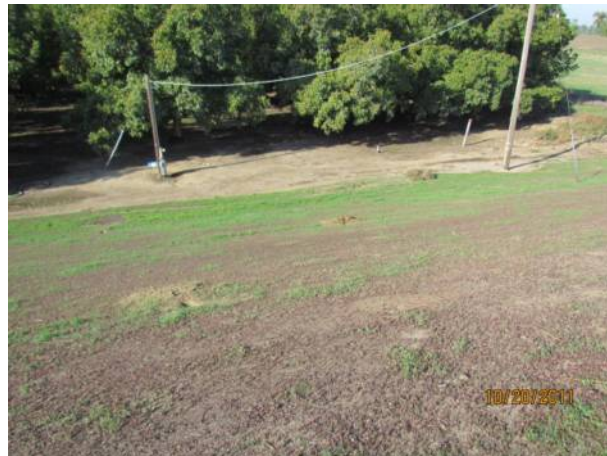
Levee Mile Report Line	4
Start Levee Mile	6.82
End Levee Mile	6.82
Location	Land Side
Category	Earthen Levee
Item	Animal Control

View of the rodent holes along the L/S slope.

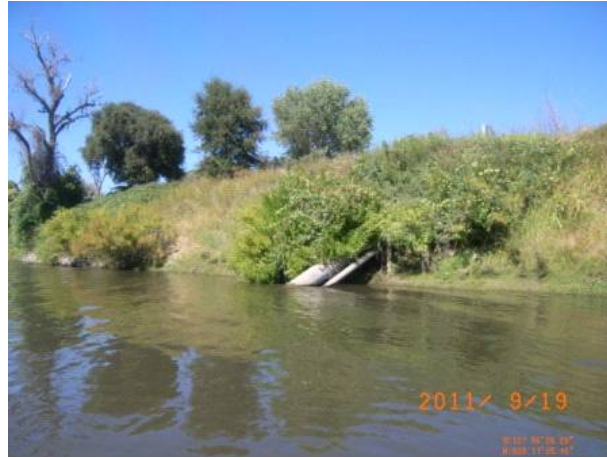
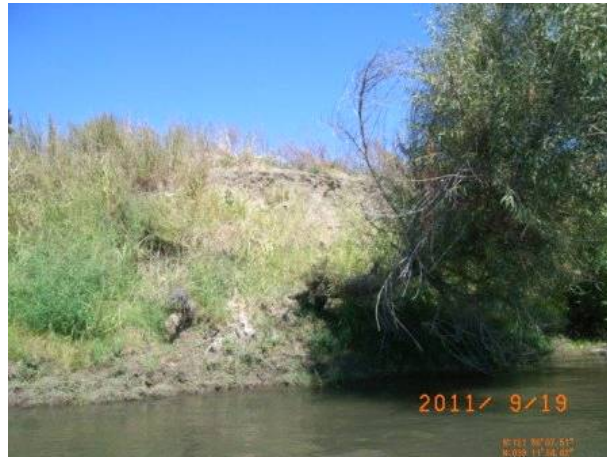
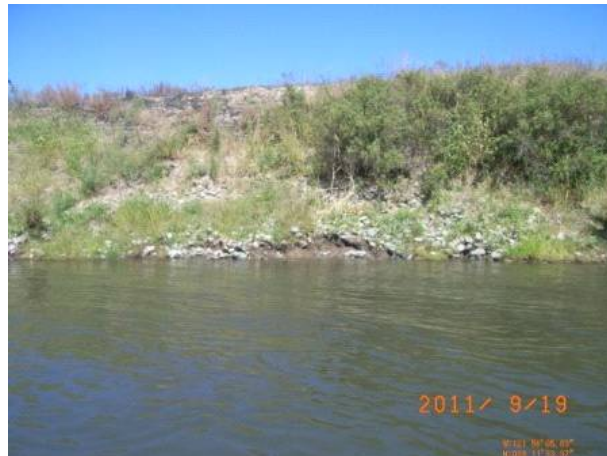
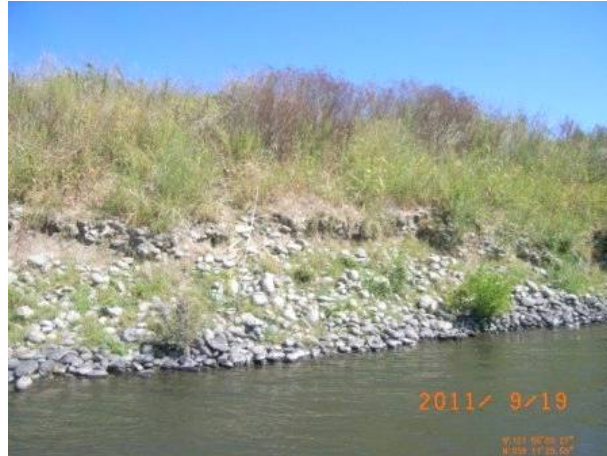
Levee Mile Report Line	1
Start Levee Mile	0.01
End Levee Mile	0.17
Location	Water Side
Category	Supplemental
Item	USACE Erosion Survey

LMR No.	Levee Mile		Category	Item	Location *	Rating **	Action/Comment	GPS Latitude/Longitude		Issue No. Photo
	Start	End						Start	End	
1	0.01	0.17	Supplemental	USACE Erosion Survey	WS	M	Inspector Comments: 1997 - Loss of cobble revetment in levee section. 2004 - New fresh erosion in a short section of the downstream end. 2010 - New deposition on cobbles. 2011: No observed change. [2011 Site ID: SAC_138-1_L]	39.193219 ° -121.935783 °	39.190038 ° -121.934199 °	10 Y
2	0.07	0.21	Earthen Levee	Seepage / Sandboils	LS	C		39.193237 ° -121.935147 °	39.191617 ° -121.933873 °	6
3	0.64	0.66	Earthen Levee	Encroachments	LS	C	Prunings	39.187511 ° -121.938304 °	39.187400 ° -121.938673 °	1
4	1.38	1.38	Earthen Levee	Seepage / Sandboils	LS	C		39.178748 ° -121.943085 °	39.178748 ° -121.943085 °	8
5	1.66	1.82	Supplemental	USACE Erosion Survey	WS	M	Inspector Comments: 1997 - Toe erosion on a cobble revetment on the outside of a low receding bend. 2011: No observed change. [2011 Site ID: SAC_136-6_L]	39.173912 ° -121.938745 °	39.172344 ° -121.937925 °	11 Y

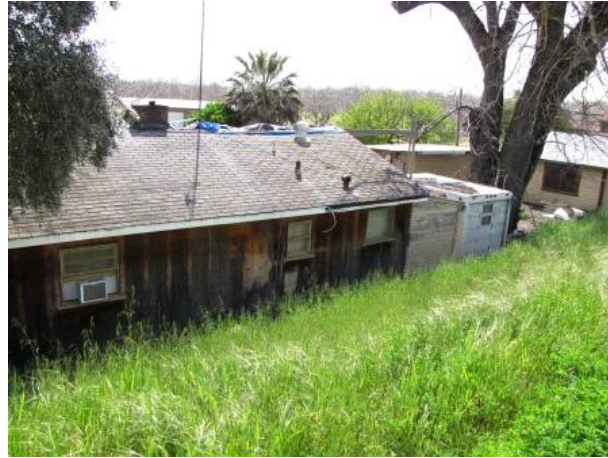
Levee Mile Report Line	16
Start Levee Mile	4.99
End Levee Mile	5.02
Location	Land Side
Category	Earthen Levee
Item	Encroachments

LMR No.	Levee Mile		Category	Item	Location *	Rating **	Action/Comment	GPS Latitude/Longitude		Issue No. Photo
	Start	End						Start	End	
16	4.99	5.02	Earthen Levee	Encroachments	LS	CO	Buildings	39.142008 ° -121.926267 °	39.142032 ° -121.926855 °	9 Y
17	5.08	5.08	Earthen Levee	Encroachments	LS	M	Prunings	39.142023 ° -121.927828 °	39.142023 ° -121.927828 °	18
18	5.10	5.10	Earthen Levee	Seepage / Sandboils	LS	C		39.141972 ° -121.928160 °	39.141972 ° -121.928160 °	19
19	5.14	5.47	Earthen Levee	Seepage / Sandboils	LS	C		39.141850 ° -121.929007 °	39.142805 ° -121.934700 °	20
20	5.31	5.43	Supplemental	USACE Erosion Survey	WS	M	Inspector Comments: 1997 - Cobble toe failures. 2000 - Erosion into the levee toe at the downstream end. 2002 - Some fresh erosion at the upstream and downstream end. 2010 - Cobble appears to be at the end of its design life, 1 - 2 ft slump in mid-bank of the cobble, upper cobble is failing. 2011: Some new minor erosion. Cobbles continue fail. [2011 Site ID: SAC_133-0_L]	39.142403 ° -121.932652 °	39.143775 ° -121.936119 °	40 Y

View of the building along the toe.

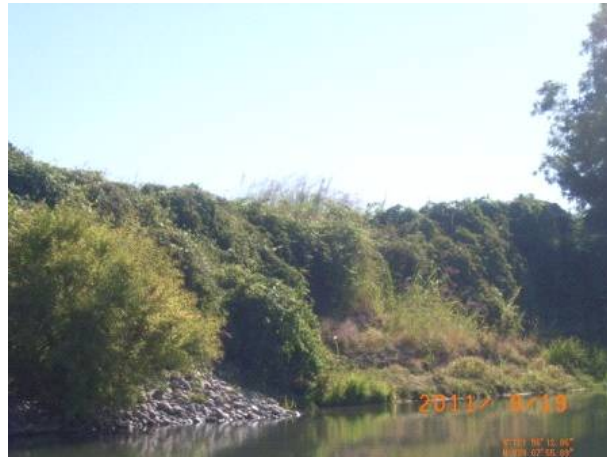
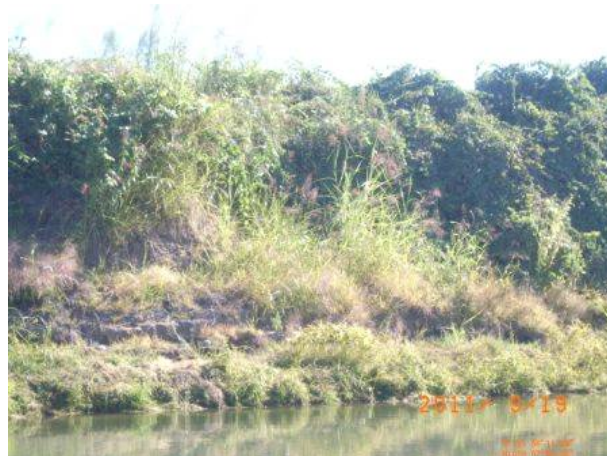
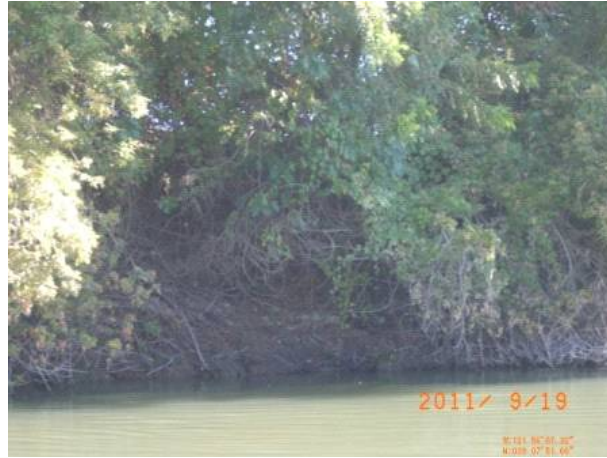
Levee Mile Report Line	22
Start Levee Mile	6.06
End Levee Mile	6.54
Location	Water Side
Category	Supplemental
Item	USACE Erosion Survey

21	5.47	5.84	Earthen Levee	Seepage / Sandboils	LS	C		39.142772 ° -121.934740 °	39.140810 ° -121.938973 °	21
22	6.06	6.54	Supplemental	USACE Erosion Survey	WS	M	Inspector Comments: 2005 - (known as 132) On inside of bend. Erosion of berm toe. Levee slope is steep. Erosion probably due to eddy scour off upstream cobble. 2009 - Groins may be a good option for repair. 2010 - Scour off the upstream rock, some new erosion. 2011: Site extended downstream. [2011 Site ID: SAC_131-8_L]	39.132040 ° -121.936521 °	39.130900 ° -121.934690 °	41 Y
23	6.35	6.47	Earthen Levee	Encroachments	LS	PO	Agricultural Ditch	39.133607 ° -121.937483 °	39.132310 ° -121.936277 °	22
24	6.47	7.15	Earthen Levee	Encroachments	LS	PO	Agricultural Ditch	39.132233 ° -121.936188 °	39.129068 ° -121.924674 °	4
25	7.25	7.25	Earthen Levee	Seepage / Sandboils	LS	C		39.128033 ° -121.923347 °	39.128033 ° -121.923347 °	23
26	7.37	7.42	Earthen Levee	Animal Control	LS	M	No rodents visible, but rodent burrows visible; need to backfill and compact or grout burrows.	39.126788 ° -121.921962 °	39.126202 ° -121.921283 °	35 Y

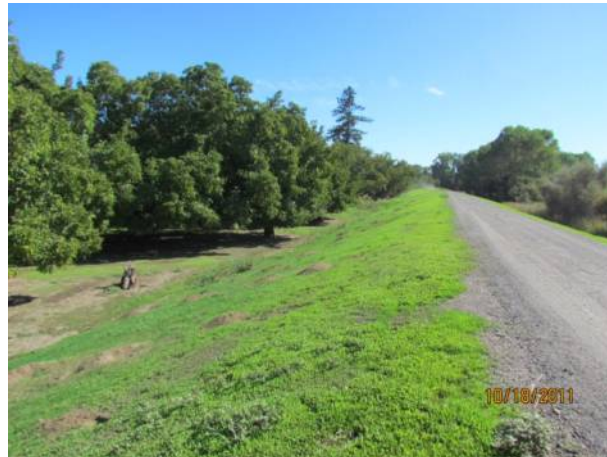
Levee Mile Report Line	26
Start Levee Mile	7.37
End Levee Mile	7.42
Location	Land Side
Category	Earthen Levee
Item	Animal Control

View of rodent holes along the L/S slope.

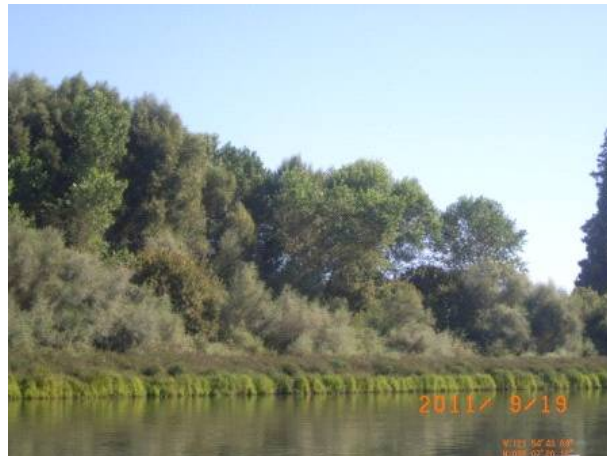
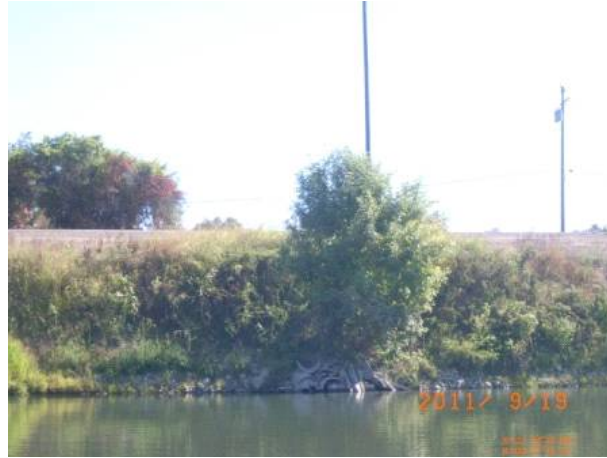
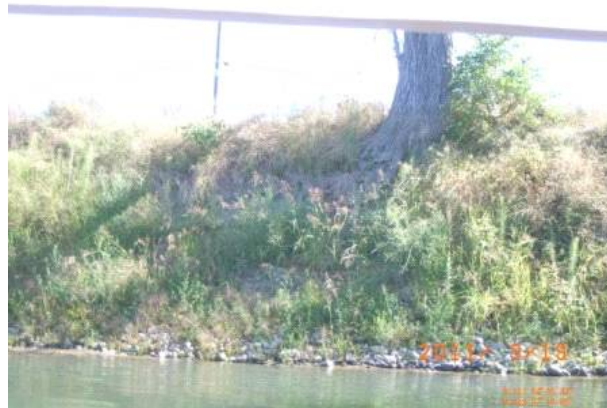
Levee Mile Report Line	28
Start Levee Mile	8.05
End Levee Mile	8.24
Location	Water Side
Category	Supplemental
Item	USACE Erosion Survey

LMR No.	Levee Mile		Category	Item	Location *	Rating **	Action/Comment	GPS Latitude/Longitude		Issue No. Photo
	Start	End						Start	End	
28	8.05	8.24	Supplemental	USACE Erosion Survey	WS	M	Inspector Comments: 1997 - Critical Site - Erosion of cobble site on outside of a bend. Failure caused by erosion of a material from behind the cobbles and cobbles rolling down the slope. Failure is just above the toe levee. Some repairs had been done at the upstream end. 2004 - Some minor new erosion at the top of the berm. 2005 - Trees look okay and the downstream end has some new rock repair. Site is no longer critical. 2006 - No longer critical, some repairs. 2011: No observed change. [2011 Site ID: SAC_130-0_L]	39.122459 ° -121.910121 °	39.120684 ° -121.909152 °	42 Y
29	8.66	8.71	Earthen Levee	Seepage / Sandboils	LS	C		39.116535 ° -121.905157 °	39.115838 ° -121.904712 °	24
30	9.46	9.52	Earthen Levee	Animal Control	LS	M	No rodents visible, but rodent burrows visible; need to backfill and compact or grout burrows.	39.105630 ° -121.900148 °	39.104883 ° -121.899842 °	37 Y

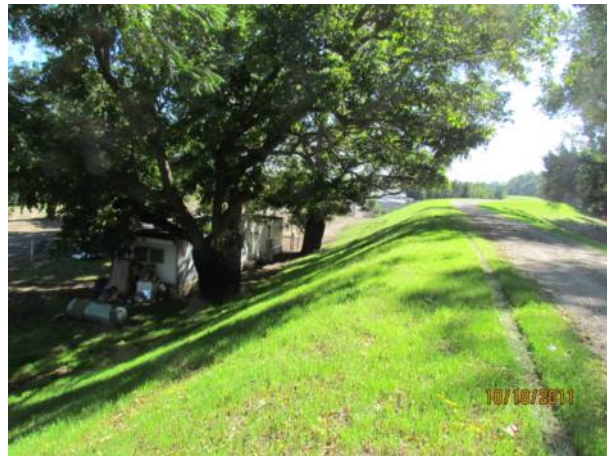
Levee Mile Report Line	30
Start Levee Mile	9.46
End Levee Mile	9.52
Location	Land Side
Category	Earthen Levee
Item	Animal Control

View of rodent holes along the L/S slope.

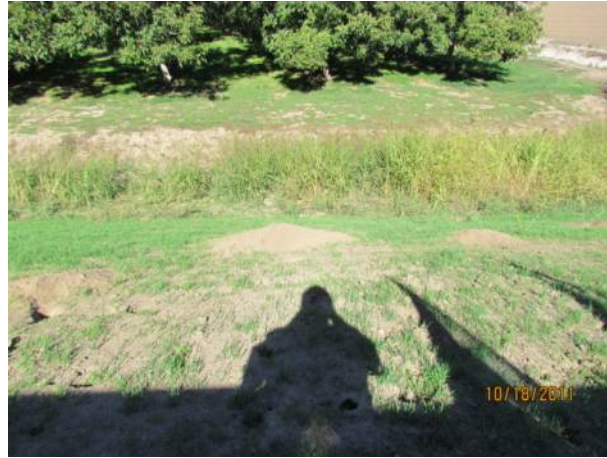
Levee Mile Report Line	35
Start Levee Mile	11.08
End Levee Mile	11.08
Location	Land Side
Category	Earthen Levee
Item	Animal Control

View of rodent holes along the L/S slope.

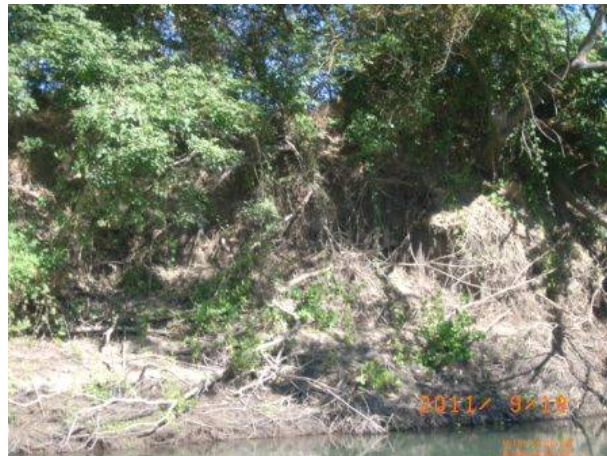
Levee Mile Report Line	41
Start Levee Mile	14.08
End Levee Mile	14.08
Location	Water Side
Category	Supplemental
Item	USACE Erosion Survey

LMR No.	Levee Mile		Category	Item	* Location	** Rating	Action/Comment	GPS Latitude/Longitude		Issue No. Photo
	Start	End						Start	End	
41	14.08	14.08	Supplemental	USACE Erosion Survey	WS	M	Inspector Comments: 2006 - Erosion into the levee toe. Rock at upstream end has poor transition causing eddy scour. 2010 - Minor new erosion. 2011: Some fresh erosion. [2011 Site ID: SAC_123-3_L]	39.069286 ° -121.857646 °	39.069166 ° -121.857995 °	44 Y
42	14.48	14.48	Earthen Levee	Seepage / Sandboils	LS	C		39.071953 ° -121.852992 °	39.071953 ° -121.852992 °	32
43	14.71	14.77	Earthen Levee	Encroachments	LS	PO	Agricultural Ditch	39.071913 ° -121.848778 °	39.071505 ° -121.847913 °	33 Y
44	14.89	15.32	Earthen Levee	Seepage / Sandboils	LS	C		39.070292 ° -121.846372 °	39.066028 ° -121.840447 °	34

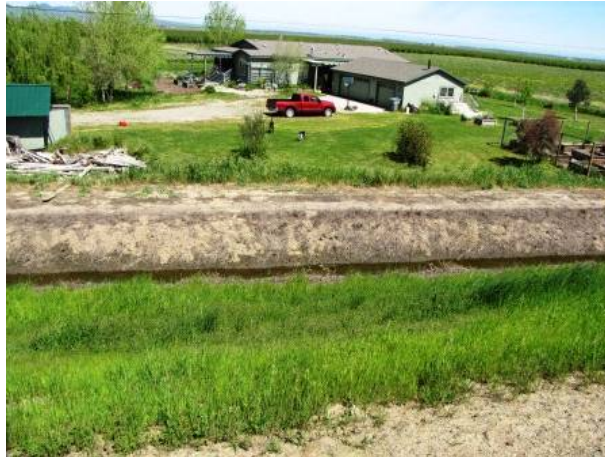
Levee Mile Report Line	43
Start Levee Mile	14.71
End Levee Mile	14.77
Location	Land Side
Category	Earthen Levee
Item	Encroachments

View of the AG ditch along the L/S toe.
